Dragging Threat – Nearly 20 Years Later: Students Trapped in Doors – A Five Second Cure to Eliminate this Threat

Peter M. Lawrence, Ed.D., CDPT* and Kathleen Furneaux, B.S., CDPT**

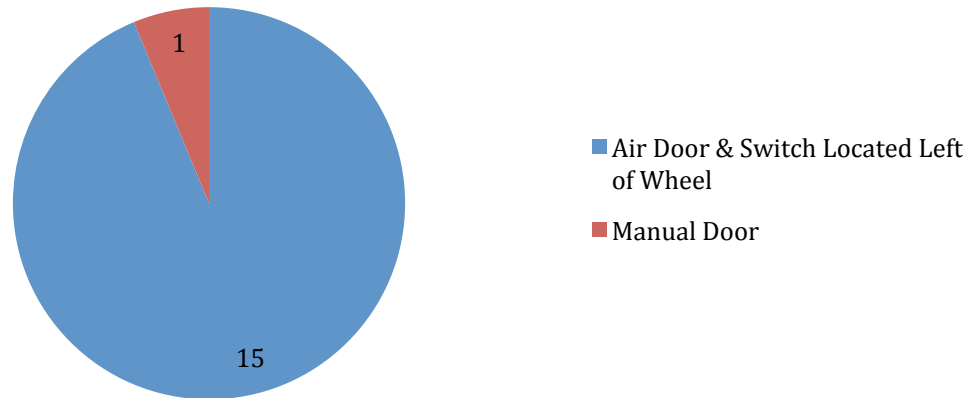
Figure 5 – Door Type & Switch Locations - Note: There were 15 Unknown Types of Door & Locations of Switches could not be confirmed by the operators or contractors.

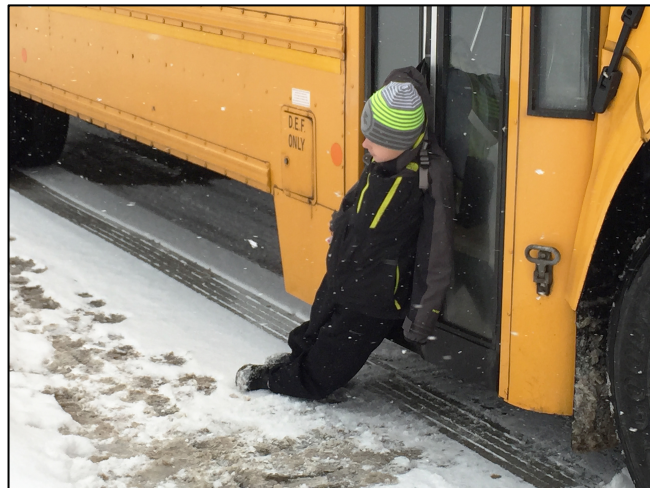
Figure 6 – Photo Compliments of Fairport CSD, NY

Similar to the handrail snagging bus design flaw, consideration should be given to

the actual placement of the service door switch. Typically this switch is located to the left of the driver on the master panel or in the steering wheel. These switch locations require the driver to look away from the door when opening or closing the door. Simply relocating this switch to a place in the sight line of the service door would allow the

driver to look in the direction of the door while operating it. This, of course, is not the complete solution, but perhaps would contribute to efforts that prevent these service door draggings from occurring.

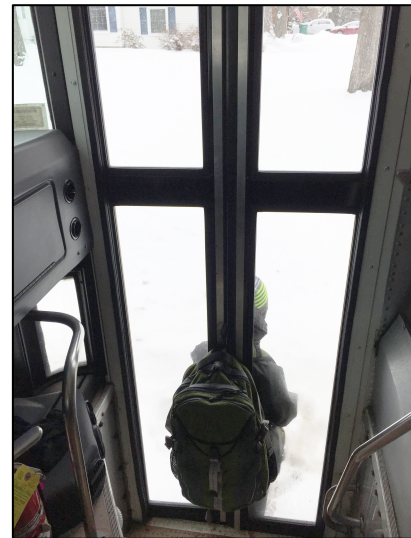
Figure 8 – Note the backpack on the inside of the service door.

These twenty-three backpack-dragging incidents could have easily resulted in fatalities if the students had slipped out of their backpacks or a strap came loose. It is important to note that all of these near misses could have been prevented by the simple five-second check that many operations teach their drivers. Prior to moving the school bus after loading or unloading students, drivers need to take five seconds to:

- Check the service door for students
- Scan all mirrors for students outside of the bus³
- Check cross-over mirrors to check for students in front of the bus, near the front wheels, and service door area
- **Next to last in the sequence – glance back at the service door to look for students before actually moving the bus⁴**
- Perform mirror sweep once again before pulling out into traffic
